National Highway
Traffic Safety
Administration

Case Vehicle (A): 2000 Honda
Type: Civic LX, 4-door sedan
Driver: 25-year-old female
CDC: 10-LYEW-3

Vehicle (B): 1978 Chevrolet
Type: Malibu Classic, 4-door sedan
Driver: Unknown – fled scene
CDC: 01-FZEW-2

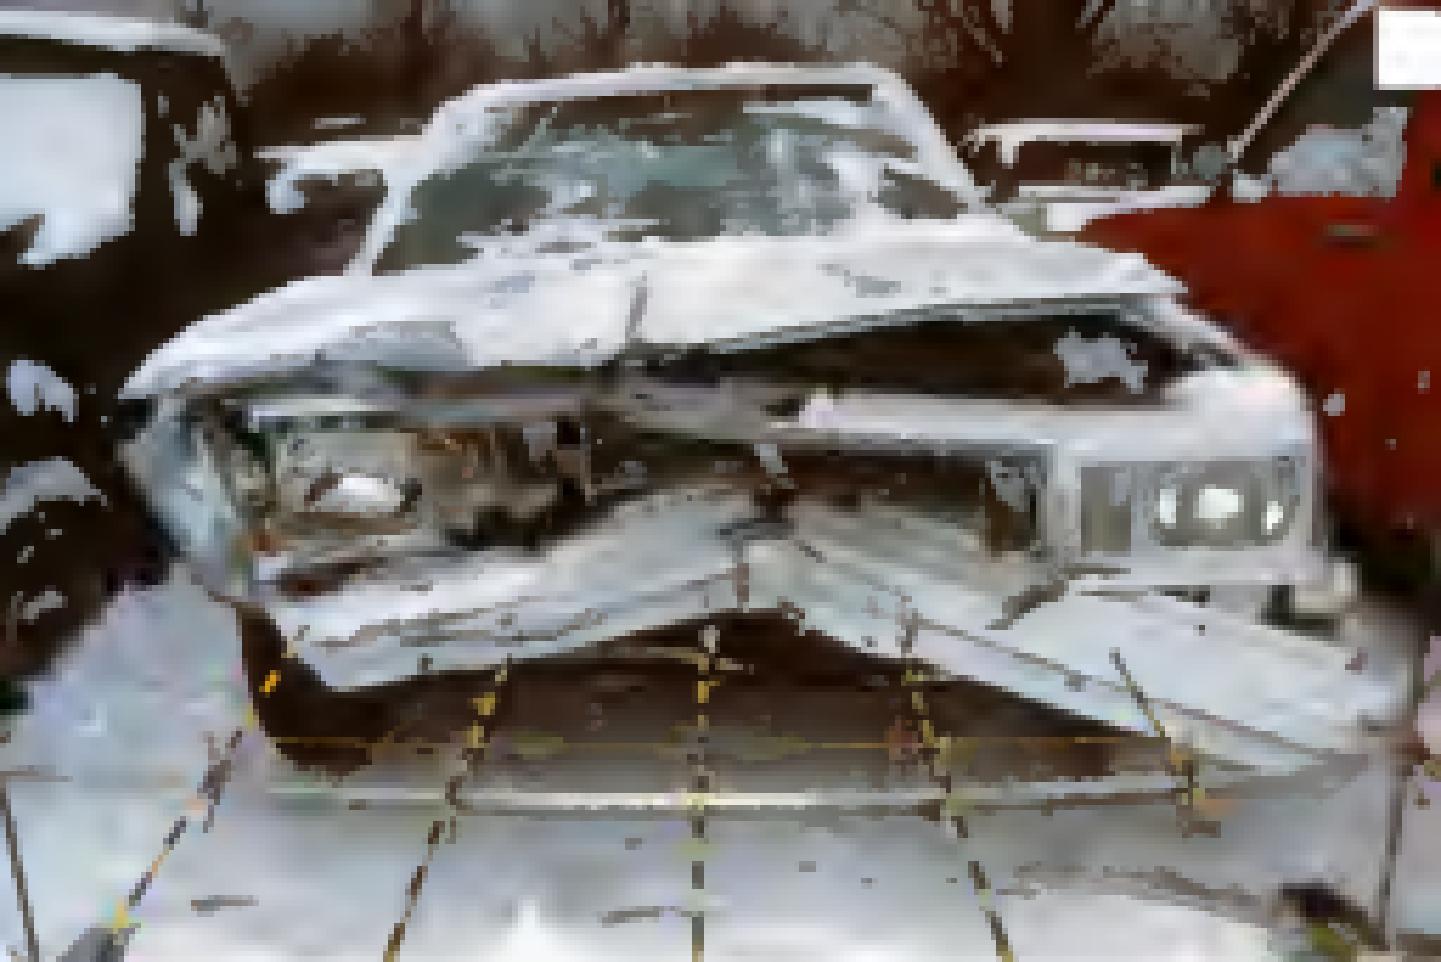
PN 23000 #7

(Slide 7) Damage to vehicle (B) was moderate. Direct damage began at the right-front bumper corner and extended 124 cm to the left, resulting in 70-percent vehicle overlap. The maximum crush was 53 cm to the right center of the front bumper. (Slide 8) The right wheelbase was reduced 4 cm and the left wheelbase was reduced 5 cm.

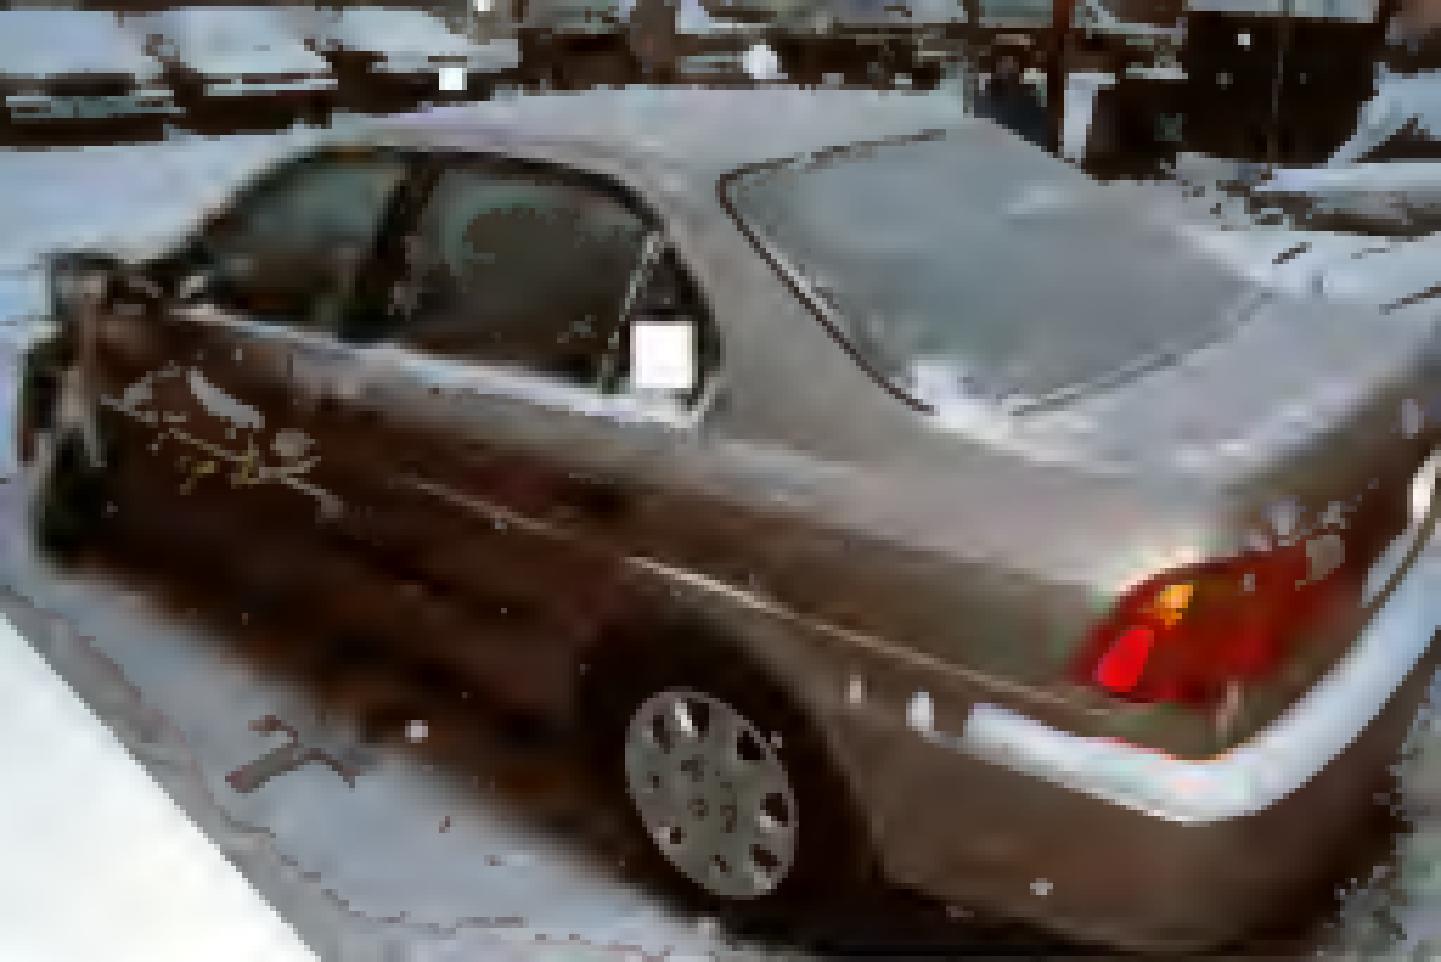
PN 23000 #17

On the left side, (slide 16) the fender, the front wheel, the lower A-pillar, and the front door were crushed inward. Both left-side doors were operational. (Slide 17) The left wheelbase was reduced 5 cm.

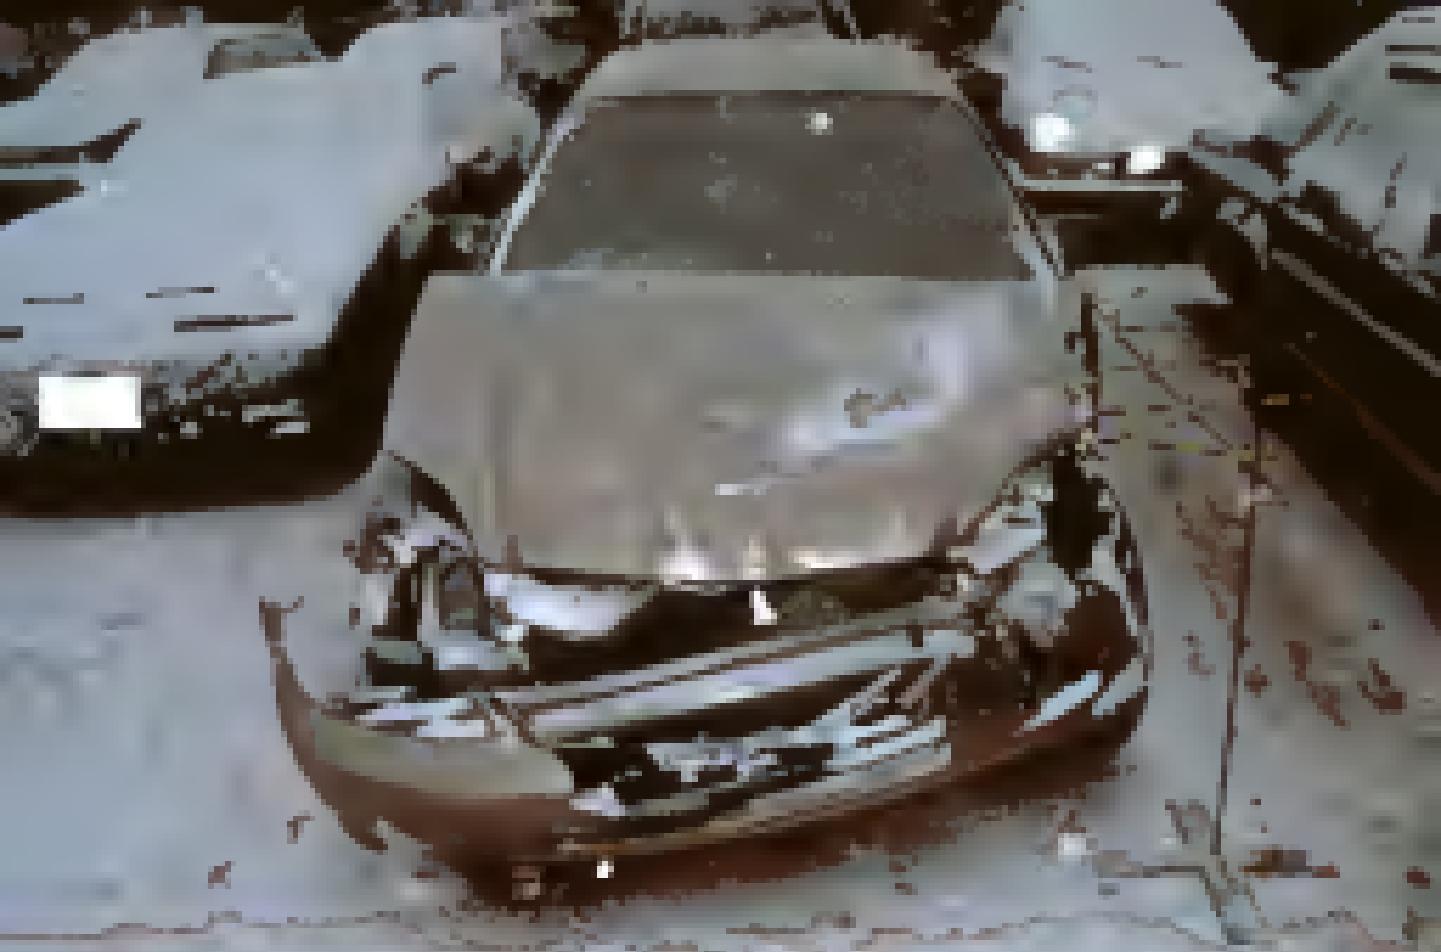
PN 23000 #18

In the front, (slide 18) the fascia, the bumper, the grille, both headlight assemblies, the hood, and both hood hinges were damaged and deflected to the right. The hood latch was damaged and jammed closed. (Slide 19) The rear edge of the hood was elevated and it contacted and (slide 20) cracked the lower left corner of the windshield. (Slide 21) The right portion of the windshield was cracked due to the deployment of the passenger airbag.

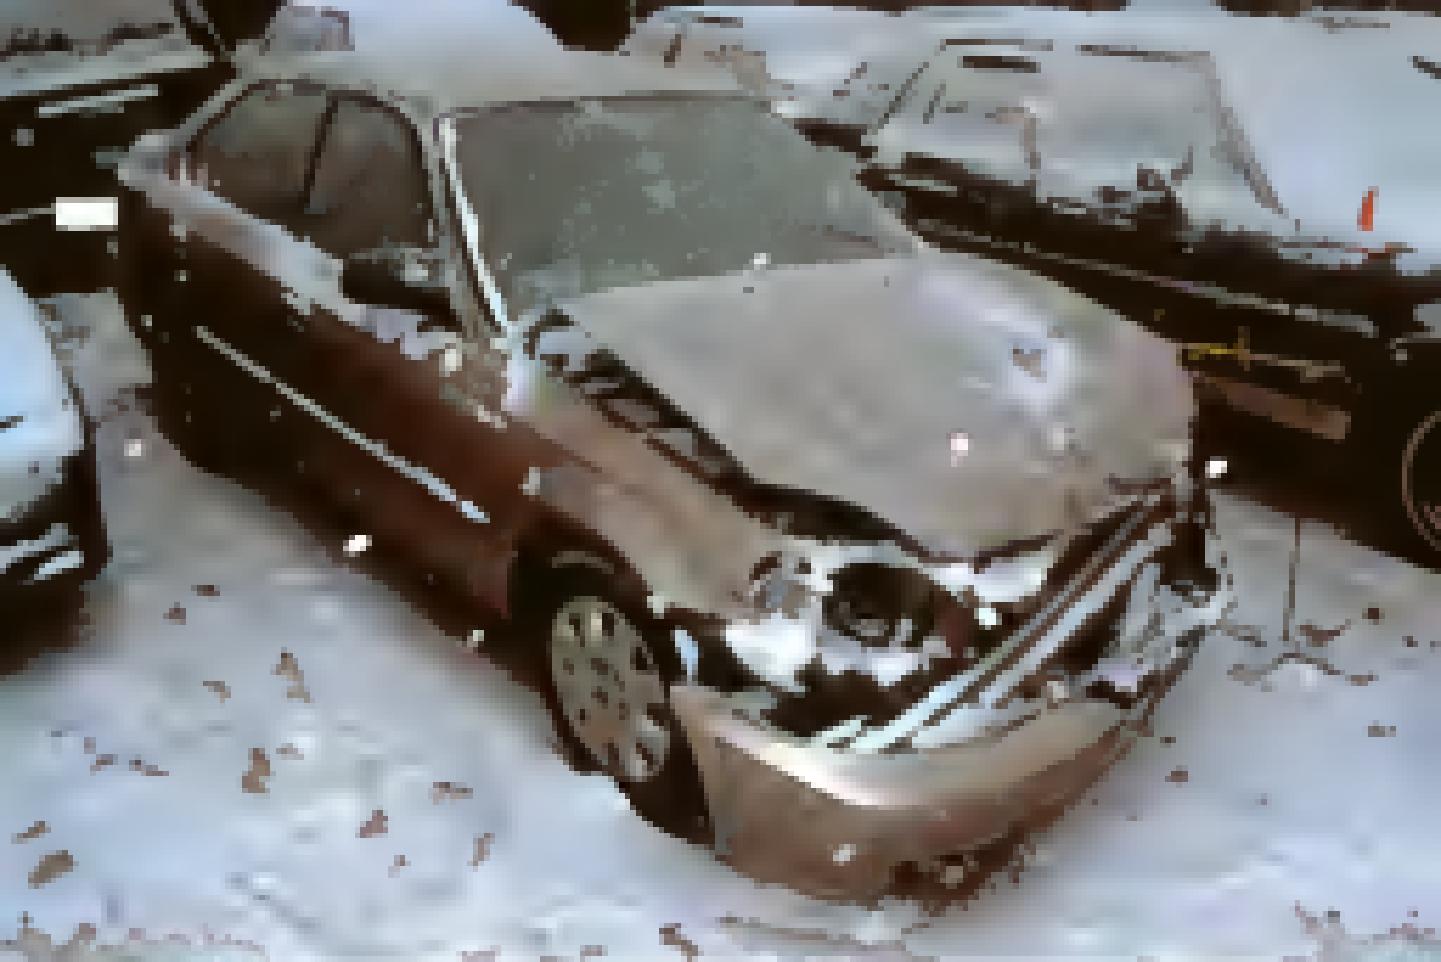
PN 23000 #22

(Slide 22) The right fender was deflected to the right. There was no other right-side damage and (slide 23) no change to the right wheelbase.
